# Success Stories

Cement Company, Egypt.

Vertical Mill.

Worn-out Roller Segments.

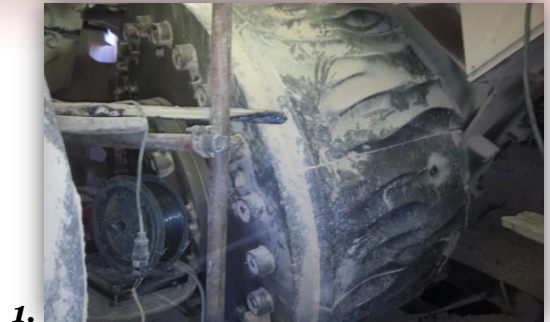
1. General View of the Mill Roller.
2. Worn-out Plate.
3. During Welding & Applying Hardfacing.
4. Application Done.
