Success Stories

Diesel Engine

A broken part from the Engine

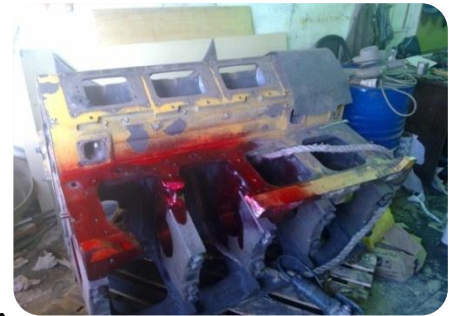
- 1- Diesel Engine Block.
- 2- Making Supporting to the broken part.
- 3- Welding Process.
- 4- Application Done.
