# Success Stories

Sleeve liner for a tug boat.

Corrosion and Wear.

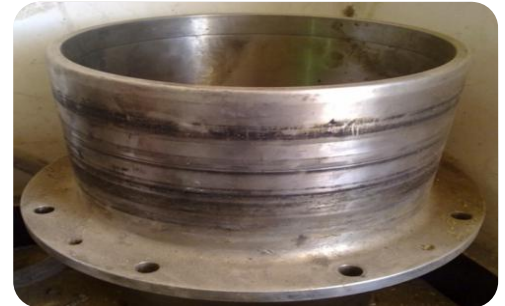
The oil Seals caused 2 mm wears in the 5 Sleeves.  
Welding the worn out areas and after grinding.

- 1- Oil Seals Caused 2mm Wear.
- 2- Welding Process.
- 3- Worn Out Areas Have Been Welded.
- 4- After Grinding 800 € Were Saved / Piece.
