BELZONA RESTORES CORRODED HEAT EXCHANGER

Tube Sheet from chiller unit

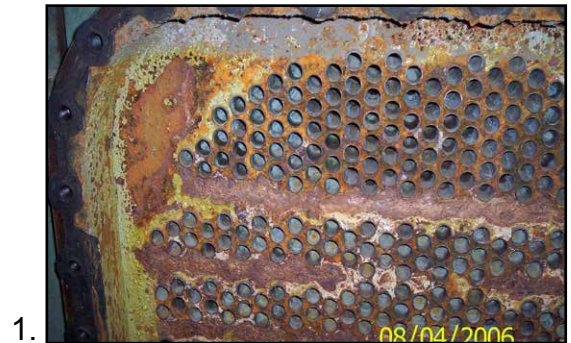
The tube sheet was badly corroded. Particularly deep erosion on tube sheet around the tubes.

1. The original corrosion damage
2. After Surface Preparation
3. Belzona 1311 application
4. Completed Belzona® 1341 application
