## BELZONA CHILLER PROTECTION

Five star hotel in Egypt

Chiller unit from the hotel air conditioning plant

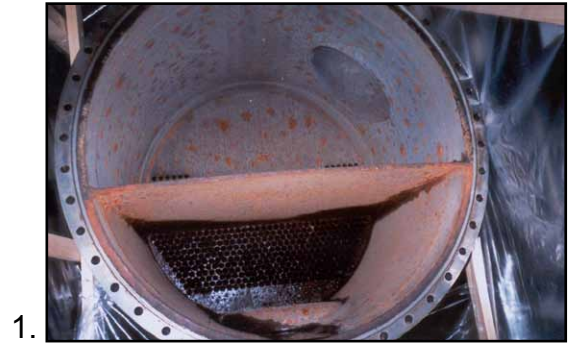
Corrosion of the tube sheet and water box.

1. The corroded water box.
2. Surface preparation.
3. Tube sheet completed.
4. Water box completed
