BELZONA® REBUILDS DAMAGED SLIDING FACE OF MILLING MACHINE

Horizontal milling machine

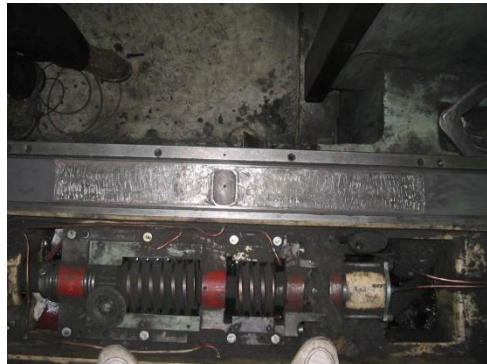
1. After surface preparation
2. Product being applied
3. Former being used.
4. Finished repair

The surface was roughened by using an angle grinder. The product was applied in excess before a specially fabricated was used to restore it to the original dimensions.

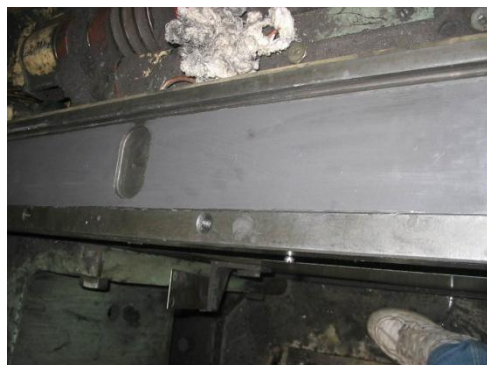
The horizontal mating face of the mill was damaged due to impact. Therefore this had to be rebuilt in order for the equipment to operate correctly.

This may be subject to excessive mechanical loads but due to the excellent compressive strength the Belzona repair is able to cope
