BELZONA[®] ROUTINE CYLINDER SALVAGE OF ENGINE BLOCK

River cruiser in Egypt

Diesel engine block from large river cruise ship

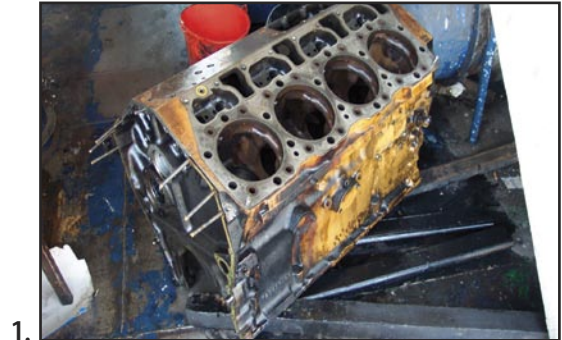
1. The engine block.
2. Location of damage.
3. Close up of the cavitation.
4. Completed application.

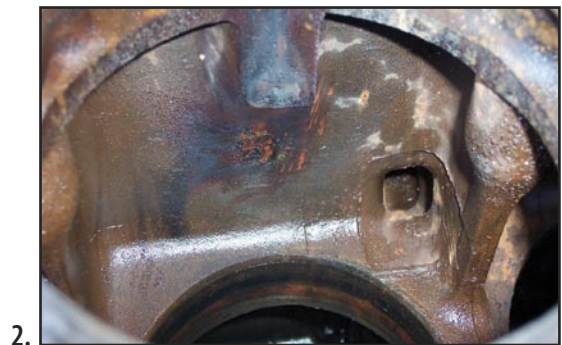
Cavitation damage in water jacket
