BELZONA REPAIRS & PROTECTS FILTERS

Five star hotel - Egypt

Media filters for the hotels swimming pool.

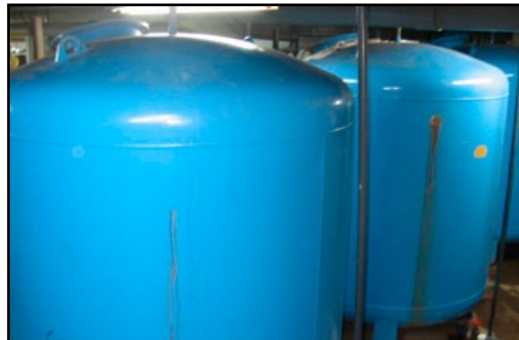
1. General view of the media filters.
2. Holes caused by corrosion.
3. Old coating failed.
4. Coating was completed after all holes were plugged.

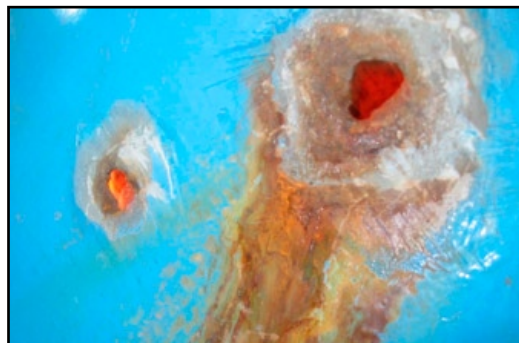
2.

Severe corrosion of the filters after the failure of its internal coating. The corrosion also caused many holes in the bodies of the filters which were leaking during operation.

Previous coating had failed causing many holes and leaks. Belzona® Marine Metal sealed all the holes, while Belzona® 1341 was used as a protective coating to prevent future corrosion. Belzona® 1341 also was chosen due to the fact that it is NSF Approved.
