BELZONA REPAIRS VACUUM PUMP

Large Phosphate production facility - Egypt

Vacuum pump

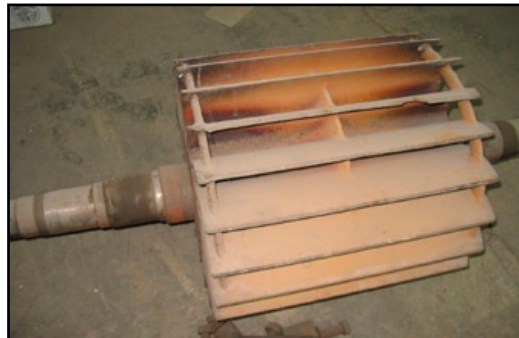
Eroded-corroded rotor and casing due to the effect of water, chemicals and limestone. The vanes of the rotor were cracked and fractured in many places.

1. The eroded-corroded rotor.
2. Repairs to cracks and fractures in the vanes of the rotor.
3. Rotor after repairing and coating.
4. Casing after repairing and coating.
