DEIONIZER COATED WITH BELZONA

Medicine factory in Egypt

Deionizer in the companys water treatment plant.

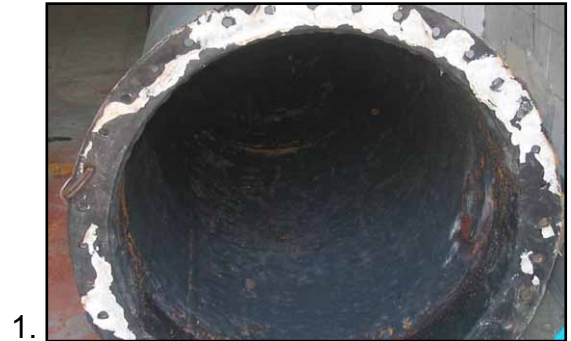
1. General view of the deionizer.
2. The failed rubber lining.
3. Deionizer from inside after coating.
4. Application completed.

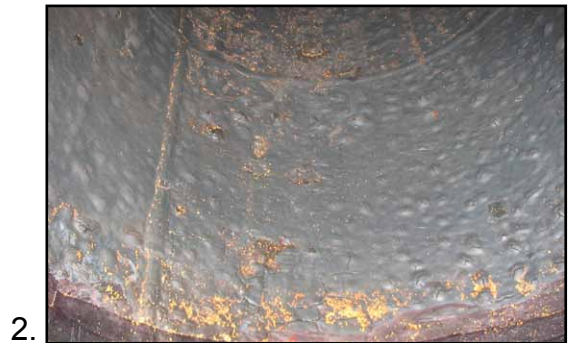
Failure of rubber lining due to aging and chemical attack.

Rubber lining was removed then Belzona® 5811 was applied to provide long term protection to the deionizer. The deionizer was inspected after a year and found to be in perfect condition. More deionizers were then coated.
