PROTECTION OF CHILLER WITH BELZONA® CERAMIC METAL SYSTEM

Hotel complex in Egypt

Chiller unit from the hotel's air conditioning plant

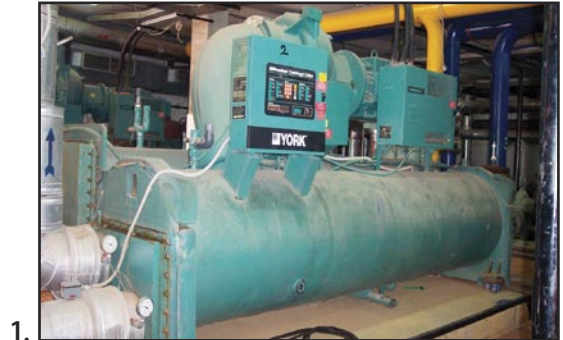
1. General view of the chiller.
2. Degree of corrosion clearly evident.
3. Corrosion pitting being rebuilt with Belzona® 1311.
4. Completed application after application of Belzona® 1321.

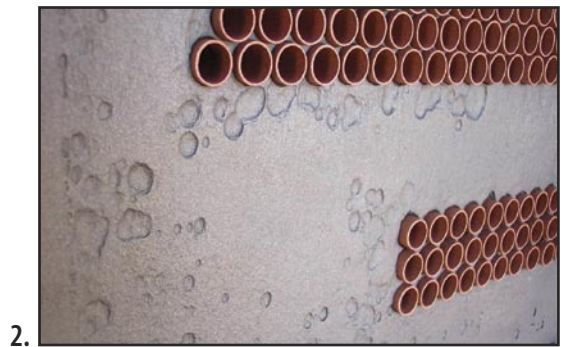
Corrosion of end covers, water box and tube sheet due to brackish water used for cooling.
