TYPICAL CHILLER REPAIR WITH BELZONA

Five stars hotel in Egypt.

Chiller unit from the hotels air conditioning plant.

Corrosion of tube sheet and the end covers.

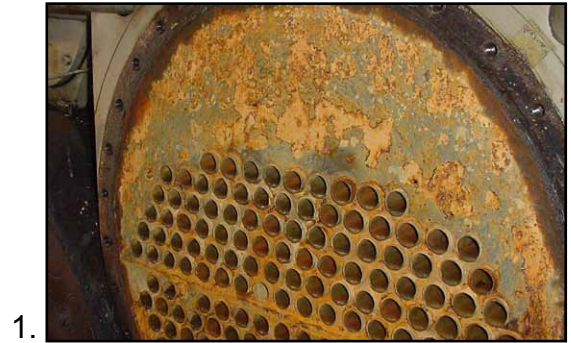
1. The corroded tube sheet.
2. Rebuilding the division bars.
3. End cover being coated.
4. Tube sheets were protected by Belzona® 1321.
