BELZONA® ENGINE BLOCK REPAIR AND PROTECTION

Iron and steel manufacturing factory, Egypt

Engine block

Cavitation and corrosion in water passages of engine block.

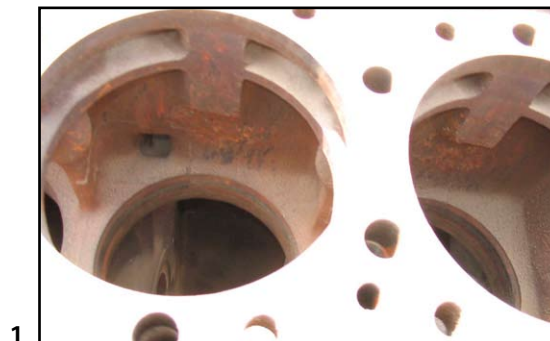
1. General view of the block.
2. Cavitation area after blasting.
3. Rebuilding cavitation area using Belzona® 1311 (Ceramic R-Metal).
4. Applying Belzona® 1391 (Ceramic-HT) to the block.
