## BELZONA<sup>®</sup> BEARING HOUSING REPAIR

Iron and steel manufacturing factory, Egypt

Exhauster fan bearing housing

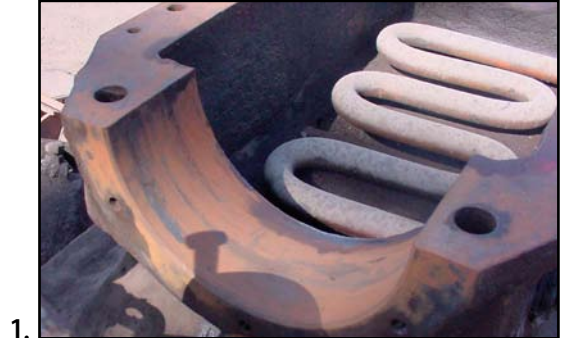
Oversized bearing housing due to bearing failure.

1. General view of the bearing housing.
2. Rebuilding of bearing housing using forming technique.
3. Bearing housing after repair.
4. The upper part of bearing housing repaired.

Belzona repaired the worn out bearing housing without welding or machining, preventing the heat distortion of conventional welding repairs. A special adjusting part has been fabricated to ensure accurate dimensions.
