BELZONA® REPAIRS PVC PUMP

PVC dosing pumps (2)

Cracked casing

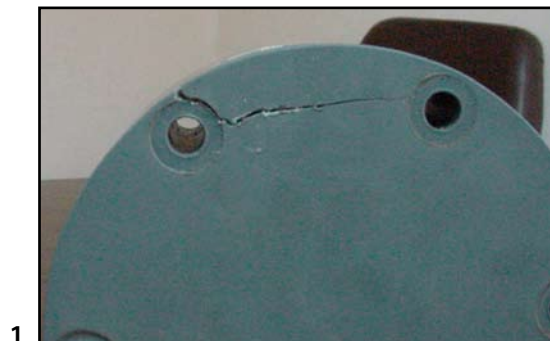
1. The crack in the PVC pump.
2. Stabilising the crack.
3. Cracks after preparation.
4. Cracks repaired.

Application was carried out in accordance with a modified version of Belzona Know-How System leaflet CEP-6. The cracks were stabilized by drilling and widening it then filled with Belzona® 1111.
