Success Stories

Ataka Power Plant, Egypt.

Diffuser.

Severe Cracks and Pitting.

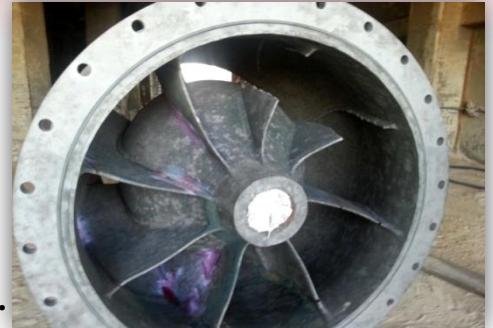
1. Diffuser Suffering Severe Cracks.
2. Worn-out Fan Plate.
3. Checking Welding Application by Dye Penetrant Test.
4. Build up Plates with Belzona 1111.
5. Application Done.

1. Cracked and worn-out plates were welded and built up with Gricast 31 and Cast Iron Electrode.
2. Checking welding application by Dye Penetrant test.
3. Belzona 1111 and Belzona 1321 Coating layer was applied for corrosion protection.
4. Diffuser was perfectly repaired and protected.
