Success Stories

Asfour for Mining and Refractories Company, Egypt

Ball mill liner

A Very Huge Crack

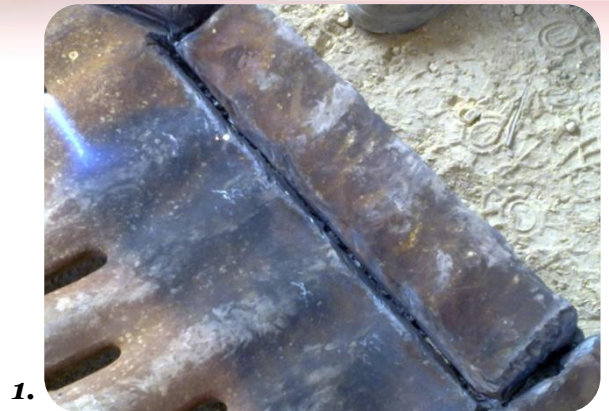
- 1- A Very Huge Crack in the Ball Mill Liner.
- 2- Preheating the Surface.
- 3- Welding Process.
- 4- Application Done.
