Success Stories

Pilco Company, Egypt

Cutter For Sheet Metal.

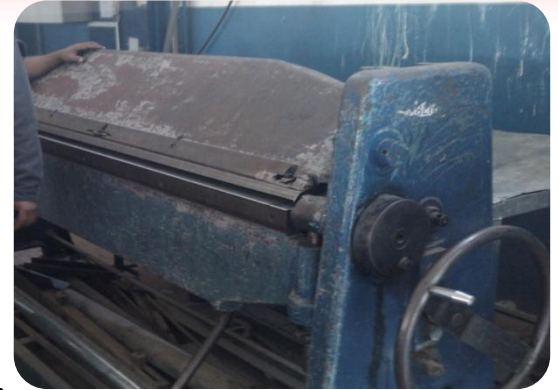
- 1- Cutter Sheet Metal.
- 2- The Cutter Had A Fracture At Its Corner.
- 3- Supporting Plates after Fixing.
- 4- Application Done.

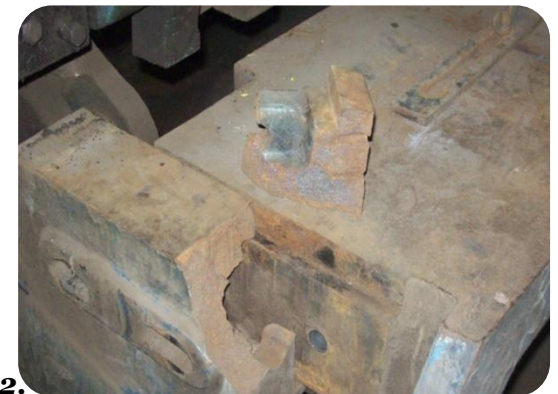
A broken part from the corner.

Cutting damaged parts to make flat surface, then manufactured another parts made of iron to support the body, then fixed and welded it to the cast iron body.
