Success Stories

Cement Company, Egypt.

Hasmag Gate.

Sever Abrasion at the gates.

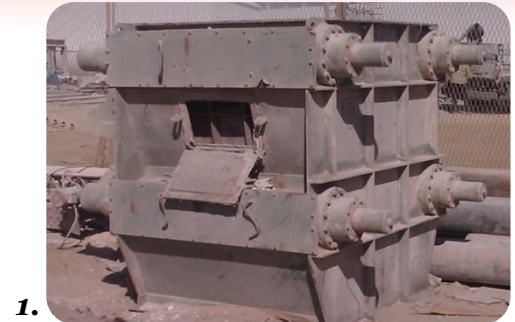
- 1- Hasmag Gate Overview.
- 2- Severe Abrasion in the Gate.
- 3- Warn Out Hinge Plate.
- 4- The Sheets after Welding.
- 5- Application Done.
