Cement Mill 2

Severe Cracks and Worn-out parts of Cement Mill Internal Body.

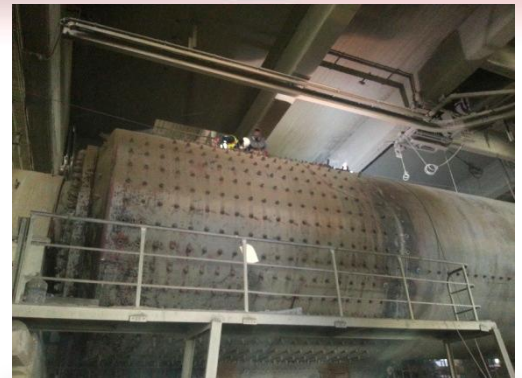
1. Overview of Cement Mill 2.
2. Internal View of Cement Mill 2.
3. Preheating Surface.
4. During Welding Process.
5. Application Done.
