# Success Stories

National Cement, Egypt.

Thrust Roller.

10cm Thickness Reduction.

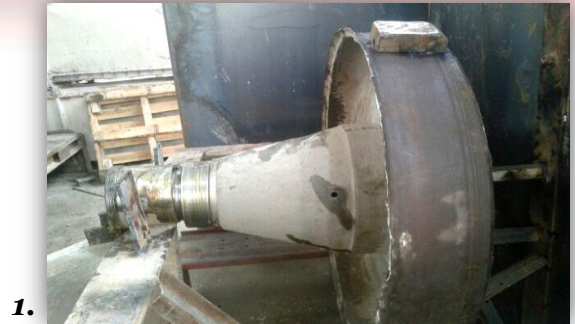
1. General View of Corroded Thrust Roller.
2. During Welding & Building Up.
3. After Rebuilding Half of Thickness Reduction.
4. Welding Done.
5. After Machining.

1. A 10cm reduction in diameter thickness was rebuilt by welding with Grini 207 and machined.
2. Thrust Roller was restored to its original diameter.
