Steam Valve

Wear and Oxidation All Over the Valve

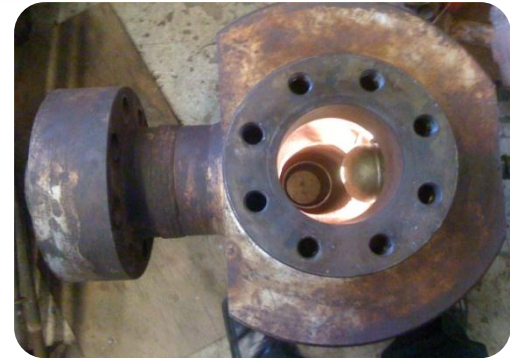
- 1- Steam Valve Overview.
- 2- Wear and Oxidation All Over the Valve.
- 3- Welding the Steam.
- 4- The Valve Has Been Successfully Repaired.
