Success Stories

Titan Cement, Egypt

Raw Mill Cover

Worn-out parts on 12 beams

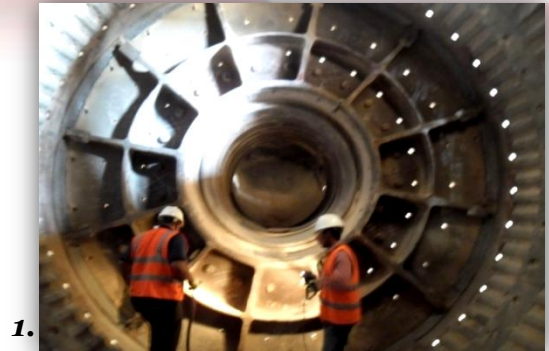
1. General View of the Raw Mill Cover.
2. Worn-out Beams.
3. During Welding & Applying Hardfacing.
4. & 5. Application Done after Dye Penetrant Test.
