# Success Stories

Torah Railways, Egypt.

Wheels wear and failure, railways welding failure, railways misalignment, I-Beam Failure and misalignment, missing pallets, concrete failure.

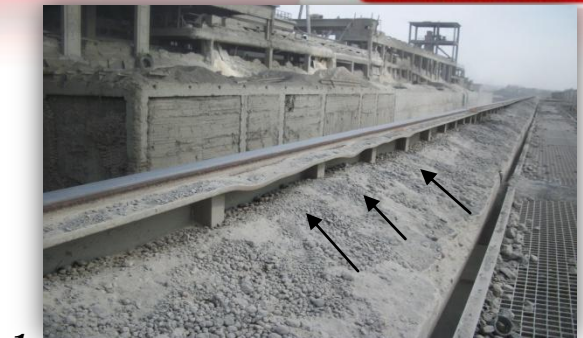
1. A Bended Railway.
2. Non Proper Welding.
3. Checking the level.
4. Insert New Studs & Plates.
5. After Fixing & Welding New Rails, Application Done.

Removing the railway and the beam (75m), Manufacture and fix plates to adjust the alignment up and down (by using different sizes of plates) and fix the missing plates. Make special concrete to fix the plates by using special Belzona concrete products, Exchange the failure beam, Fix the beam, Exchange the railway, Fix the railway by welding.
