# Success Stories

Steel billet cutter

A fracture and a lot of cracks

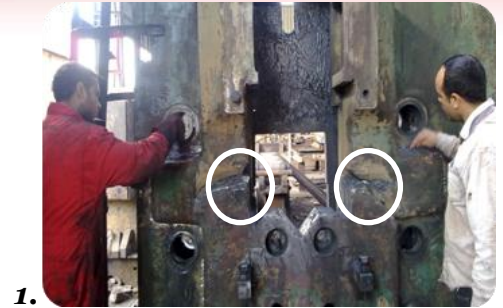
- 1- Severe cracks
- 2- Grooving
- 3- Welding the left side
- 4- Welding the right side
- 5- Application Done

Check cracks with Dye penetrant, grooving , then applying various welding passes to support the body.
