# Success Stories

National Cement Company, Egypt

Ball Mill

Severe cracks at the Mill Head, Trinion and Shell.

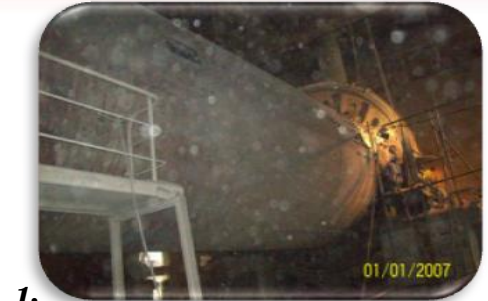
- 1- The Huge Ball Mill Full of Cracks
- 2- Severe Cracks
- 3- Grooving to start Welding
- 4- Preheating to add another Layer of Welding
- 5- Welding Done Successfully.
