Success Stories

ORASCOM, Egypt

Pump Casing

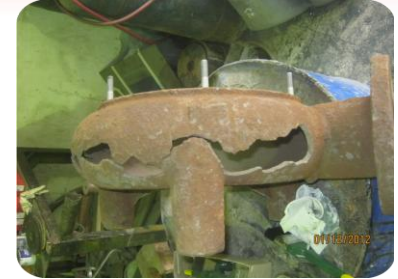
1.

The pump casing was broken and there were many missing parts due to neglected crack around the whole casing.
