BELZONA®
KNOW-HOW *In Action*
Volume XVIII No.31

BELZONA® REPAIRS MASSIVE FAILURE OF KILN SUPPORT CASINGS

CUSTOMER
Cement works in Egypt

APPLICATION SITUATION
Rotary kiln used in cement production

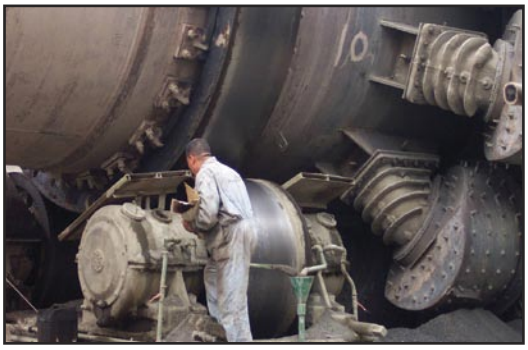
PROBLEM
Casings on trunnion supports shattered due to the breakage of the roller neck.

PHOTOGRAPHS
1. General view of the trunnion supports.
2. The shattered casings.
3. One of the fabricated strengthening plates in position.
4. Belzona® 1111 used to bond and seal the cracked casing.

BELZONA FACTS
Various strengthening plates and straps were used to add strength to the repairs. Two large casings were completely restored. Alternative was the replacement at the cost of $20,000 each and six months delivery time.
