# Success Stories

Cement Company, Egypt.

Vertical Mill.

Worn-out Roller Segments.

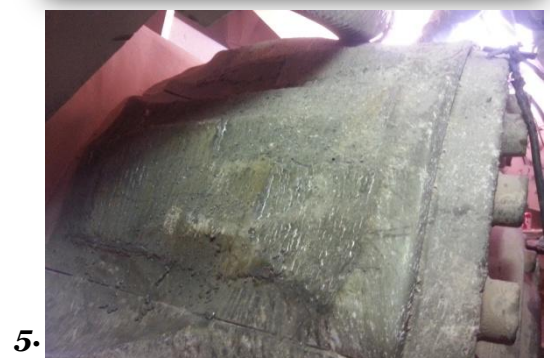
1. General View of the Mill Roller.
2. Worn-out Plate.
3. During Welding & Applying Hardfacing.
4. Application Done.

1. Cracked plates of the Mill Roller were welded.
2. Worn-out segments were rebuilt by 2 Build Up layers and 2 Hardfacing layers.
