## BELZONA PROTECTS FANS FROM ABRASION

Tobacco company, Egypt

Suction fans

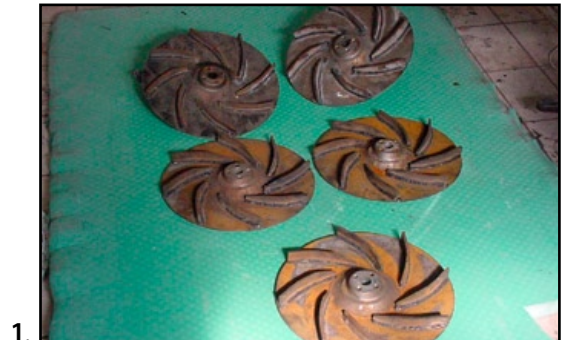
1. General view of tobacco suction fans.
2. Fans following surface preparation.
3. Fans coated with Belzona<sup>®</sup> 1812 (Ceramic Carbide FP).
4. 5 fans were protected.
