BELZONA REPAIRS RUBBER GEAR CASTING

Cooking vessel manufacturer, Egypt

December 2001

Rubber gear

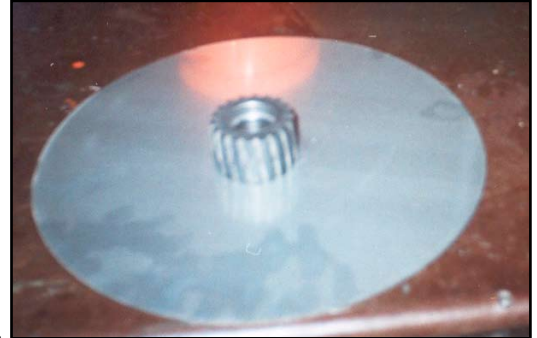
1. The rubber section which needed to be cast.
2. Preparing the mould.
3. Rubber mould completed.
4. The cast gear and the mould ready to cast another new gear.
