BELZONA PROTECTS STAINLESS STEEL FROM ACID FUMES

Fertilizer manufacturer, Egypt.

Tanks, dryers and pipes in fertilizer production plant

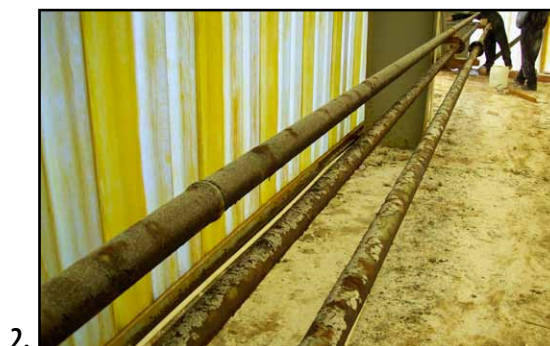
Stainless steel suffering corrosion and attack from HCl fumes generated in the production process.

1. General view to the factory
2. Corroded stainless steel pipes
3. Cleaning the surfaces
4. Application completed
