Success Stories

Cement Company, Egypt.

Cement fan.

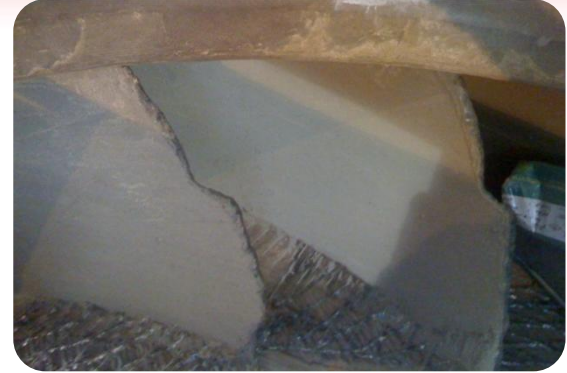
- 1- Cement fan.
- 2- Vanes were worn out .
- 3- Selecting only the Areas that exposed to Sever wear as an economic solution.
- 4- Application Done.

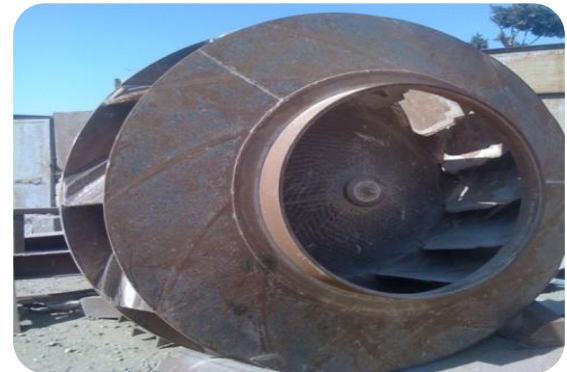
Abrasion
