National Company for Maize Products, Egypt

Starch Knife.

Wear and lost sharpness.

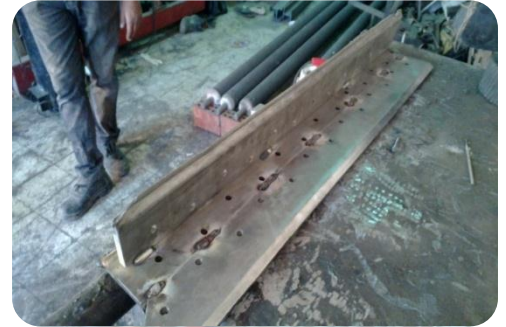
- 1- Starch Knife that exposed to wear and lost its sharpness.
- 2- Hardfacing the edge.
- 3- Grinding the edges.
- 4- Application Done.
