Success Stories

Lime Stone Crusher

Cracks and wearing

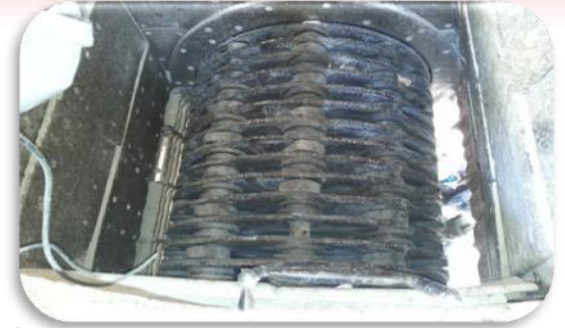
- 1- Lime stone crusher.
- 2- Cracks.
- 3- Grinding, buildup and hardfacing.
- 4- Welding done successfully.
