Success Stories

Titan, Egypt

Clinker cooler crusher

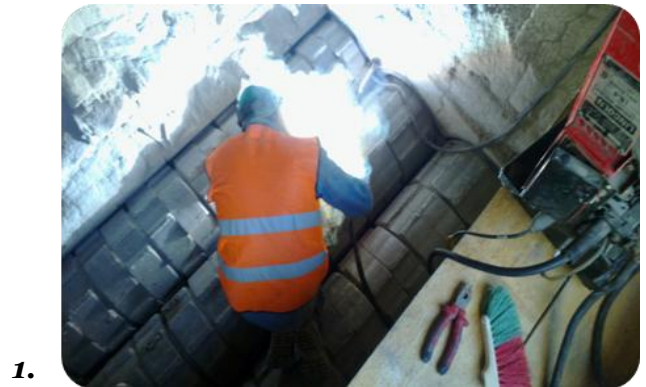
Abrasion

- 1- Hardfacing Process.
- 2- Hardfacing Process
- 3- Application Done Perfectly

Lincore 65-0

Surface Preparation , cleaning using MEK and hardfacing process by Fluxcored Hardfacing wires.
